# What caused the corrosion: The Question

Michelle Woolley - November 25, 2013

The case: corrosion on printed circuit board assemblies (PCBAs). Here is all the information we obtained through conversations and visits to the customer's facilities (because the corrosion was happening at the customer's sites). With this information, you can formulate your own theories. In "What Caused the Corrosion: The Answer," I will show you the resolution and explain it.

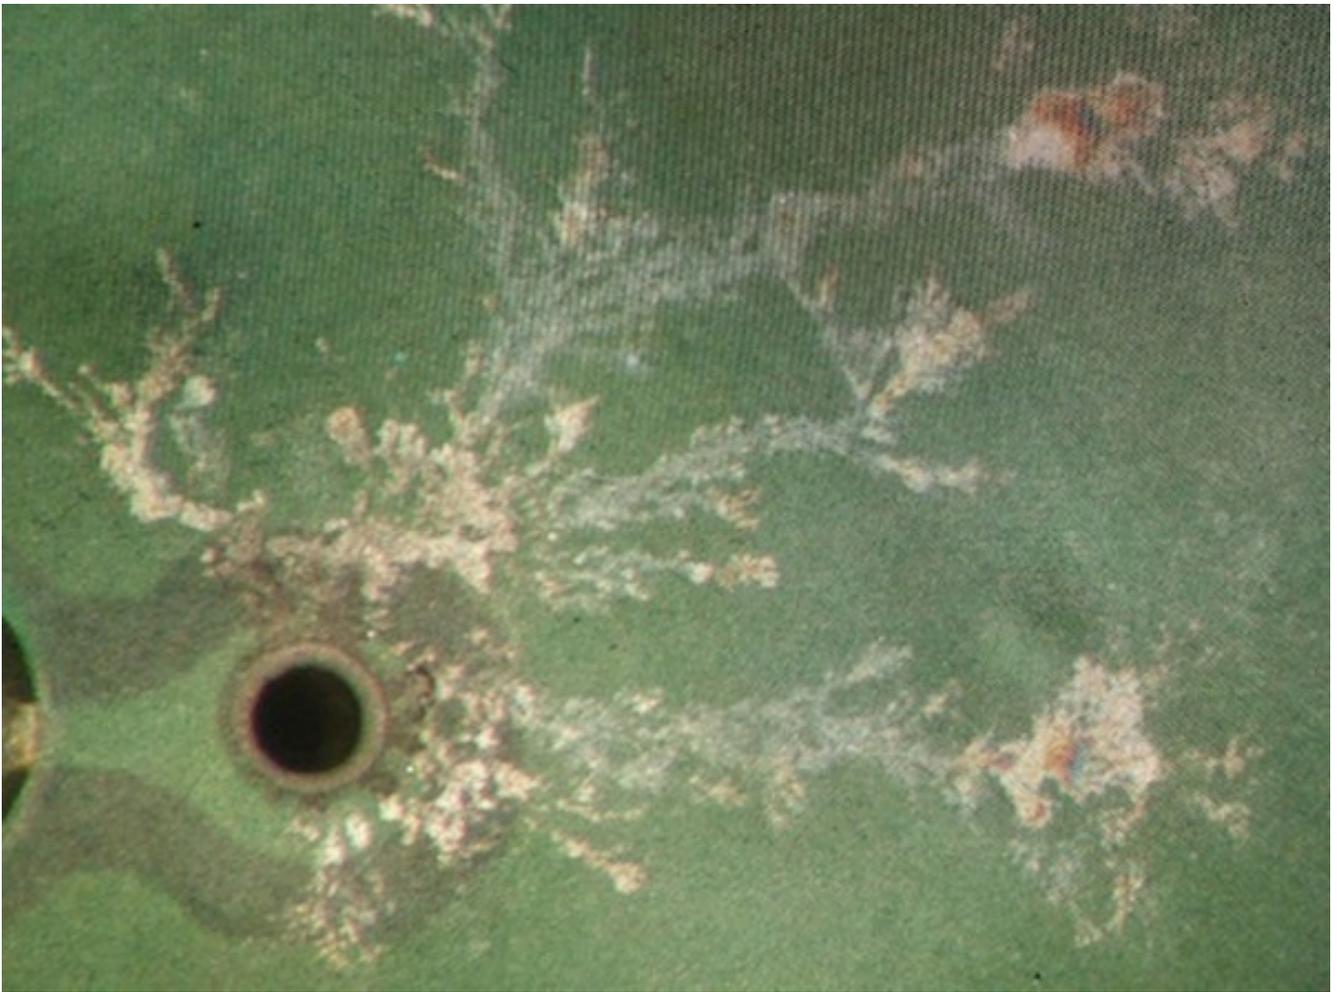
FIGURE 1

1. The PCBAs were from different facilities that were located in the southern part of China, Hong Kong, and Japan.
2. The corrosion was very extensive. In many cases, the PCB had been thermally degraded between two conductors. The conductors most affected carried voltage differentials of 180VAC. Figures 1- 3 show some of the most severe corrosion product that spread across the PCB surface.

5. Most of the corroded areas were not uniform around the centers but was biased toward one side as is shown in Figures 1 and 2.

9. Standard Corrosion test plates (copper and silver) were placed in the room and did not see significant corrosion during a 60-day period.
10. The main element detected in the corrosion product was sulfur. In some samples, chlorides were present. The presence of chlorides was not related to the amount of damage.

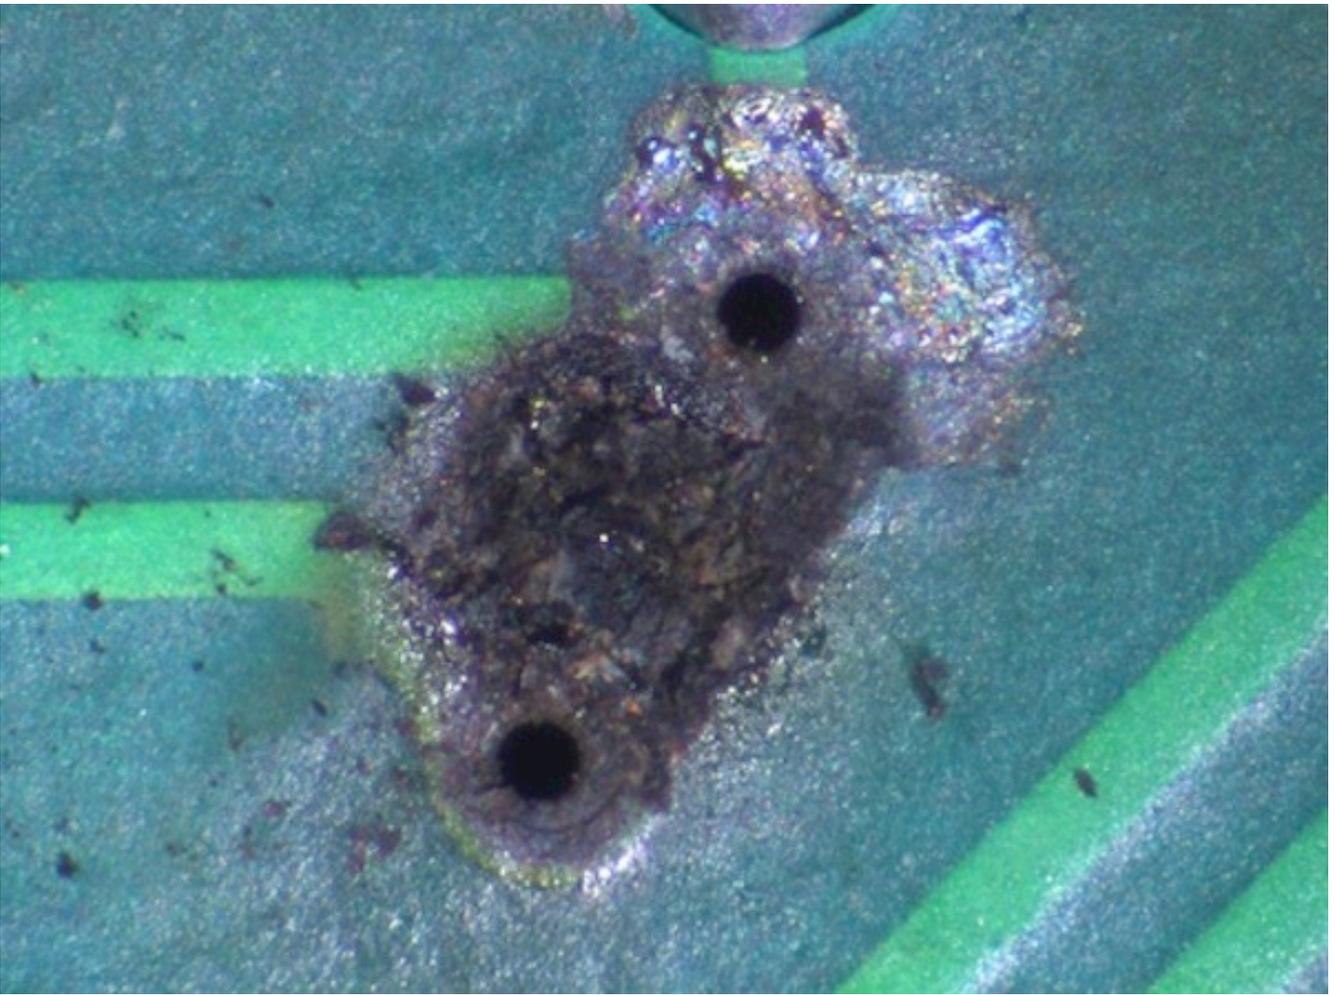
FIGURE 4

3. Figures 4 and 5 show an optical image and a SEM image of a burned area clearly showing the damage to the PCB. In order to produce this damage, enough current must have passed between the two conductors to heat the wiring beyond its degradation temperature. The PCB had a degradation temperature greater than 260C. There were no anomalies associated with the printed wiring board (PWB).
